Destruction Test Report

Customer: Blakley Electrics

Destruction Test Item: Galvanised Steel Electric Housing Box

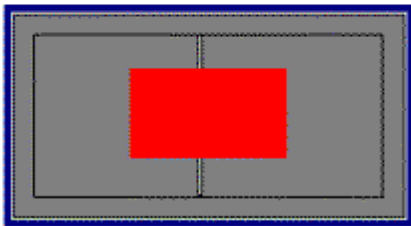
Top View

Blue - Test frame
Grey - Electric Housing Box
Red - Test Pressure Plate
